Design Change Notification

REFERENCE : SYN19131

Equipment : *EPSILON CLOCK EC20S*

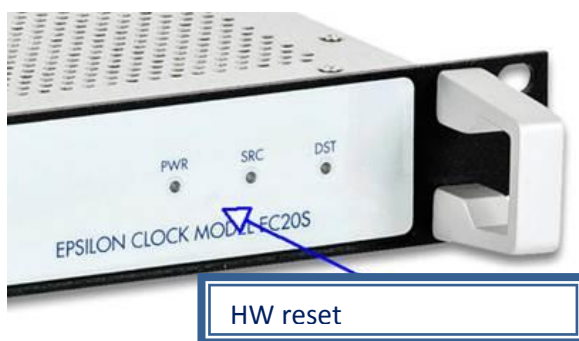
- A) If your product version is **below** 2.02 (exclusive) :
- Install first the patch – XXXXXX and let the unit reboot.
 - Install the new release and let the unit reboot.
 - At the end of the installation, your password will be invalid (even if it's not modified).
 - With a clip, press the button 'factory reset' on the front panel of the product as shown below:

- Wait 5 minutes for the reboot.
- At this stage, your product has a fixed IP address (@192.168.0.100), with factory configuration and 'pwd' as standard password.
- Configure your product (Network, user's parameters).
