Software Version 1.3.1: Release Notes

Spectracom released a software update for VersaSync and VersaPNT. Customers can download this software update at no charge from the Spectracom website (see [How to download and install the new SW.](#)) This latest software update will upgrade the unit's system software to **Version 1.3.1**.

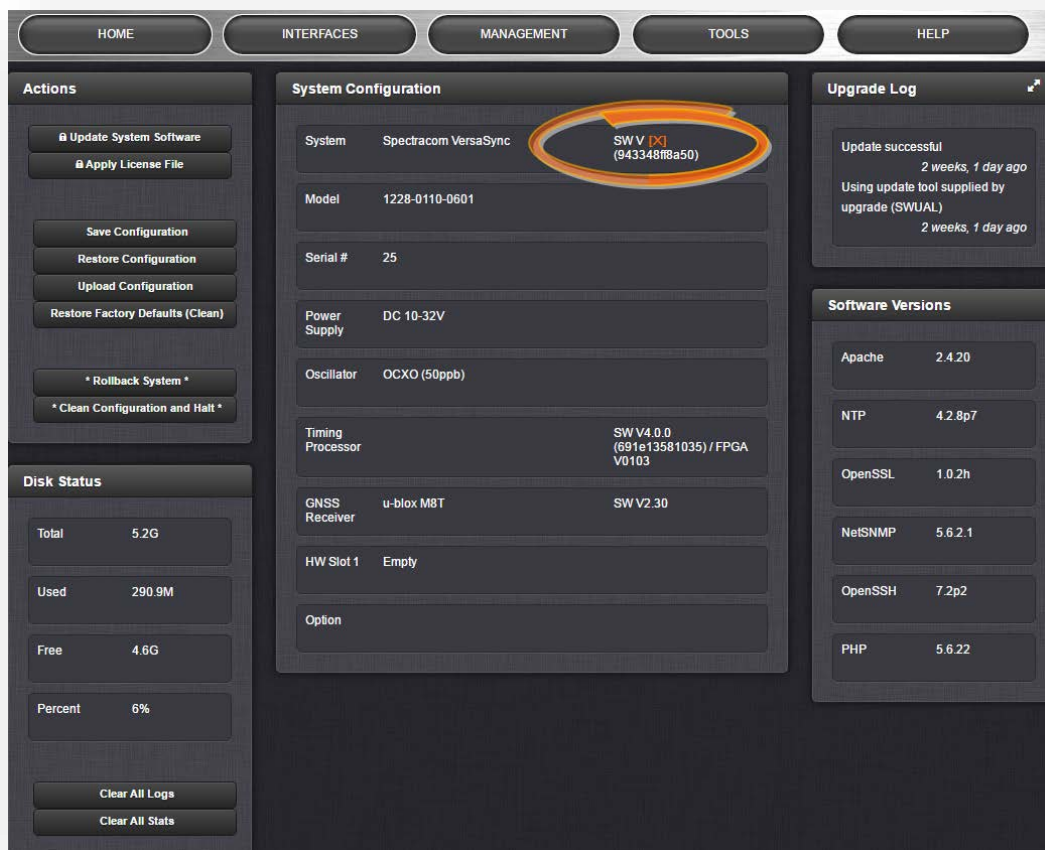
1. Login to the unit's Web UI
2. Navigate to **Tools > Upgrade/Backup**. The **System Configuration** panel in center of the screen displays the current version number under System:

Figure 1: Software revision reported under **Tools > Upgrade/Backup**.

To determine the software version currently installed on your unit:
